**Fairview - AS 4284 testing on facades**

**Test Report - Stryum with Flexible Membrane**

30B-19-0059-TRP-6774700-2

Vipac Engineers and Scientists were commissioned by Fairview Pty Ltd / FVA Group Pty Ltd (the client) to perform AS/NZS 4284:2008 testing for their cladding system.

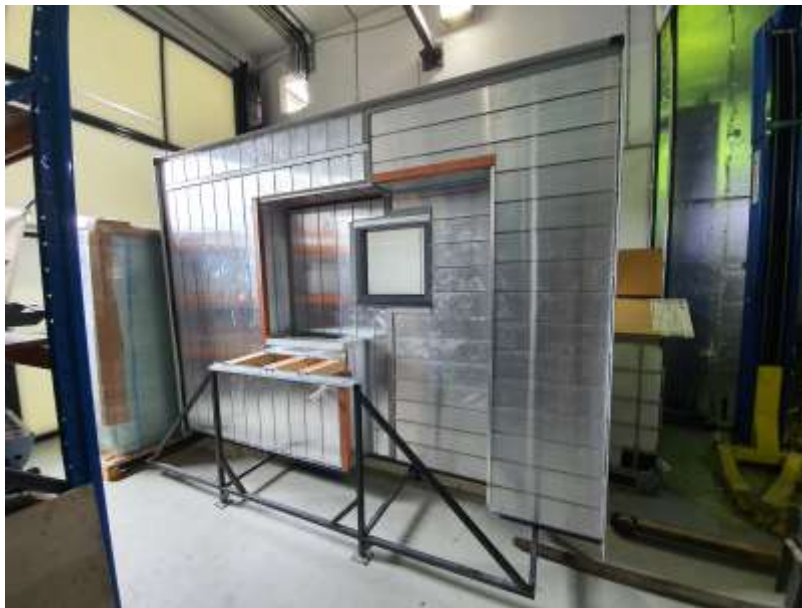
*Figure 1: Test Sample prior to installation*

Details of the test sample can be found in Appendix A and B of this report.

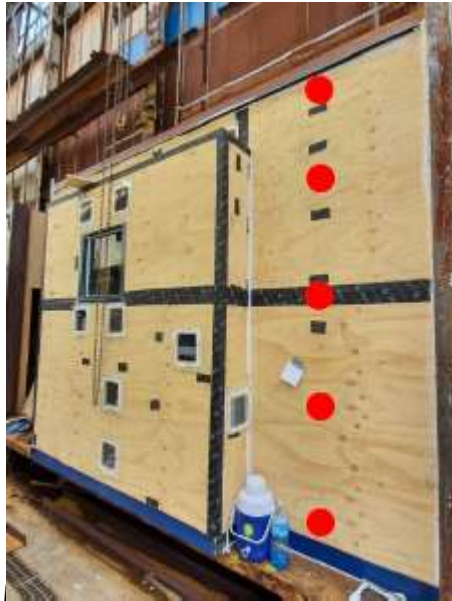
*Figure 2: Node locations (1-5 from bottom to top)*

Zero Stage	Node 1 [mm]	Node 2 [mm]	Node 3 [mm]	Node 4 [mm]	Node 5 [mm]
<b>Z1</b>	0.00	0.00	0.00	0.00	0.00
<b>Z2</b>	0.04	0.06	0.03	0.06	0.06
<b>Z4</b>	-0.81	-1.01	-1.21	-0.94	-0.51
<b>Z5</b>	-0.83	-1.05	-1.27	-0.99	-0.54
<b>Z7</b>	0.05	0.06	-0.04	0.00	-0.06

**Conclusion:** The test sampled complied with the structural span deflections limits of Span/250.

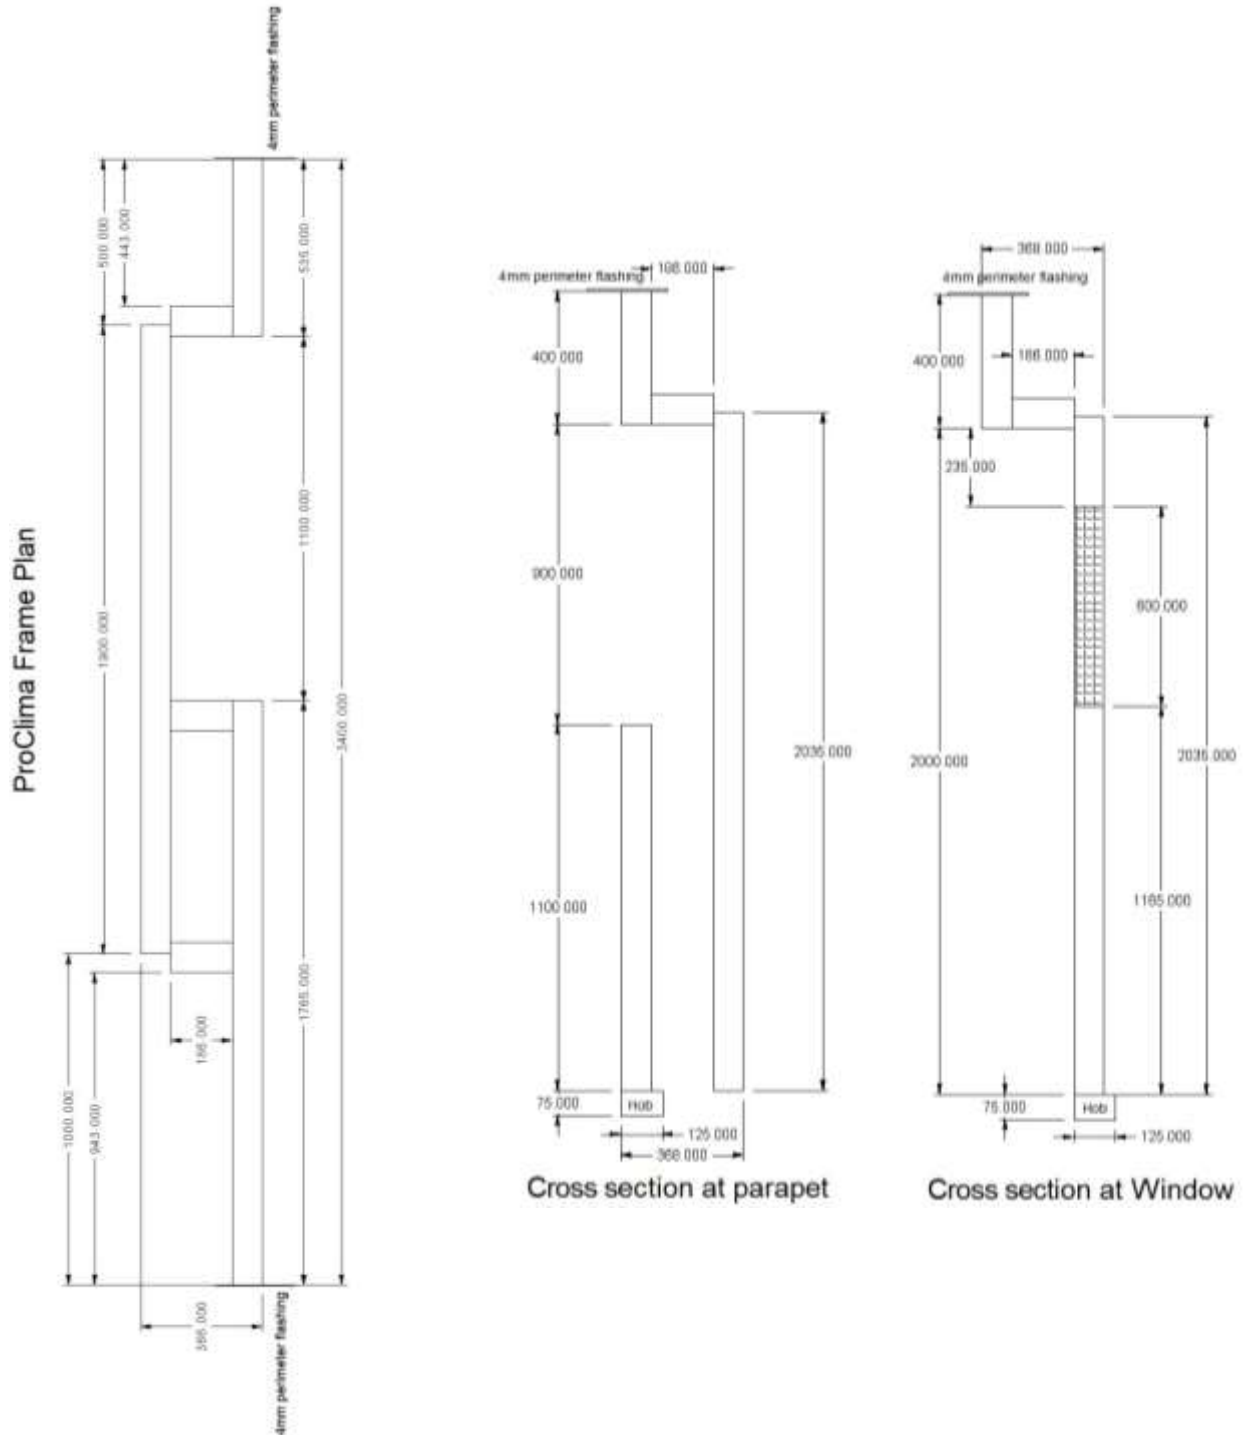
Back Frame Proclima

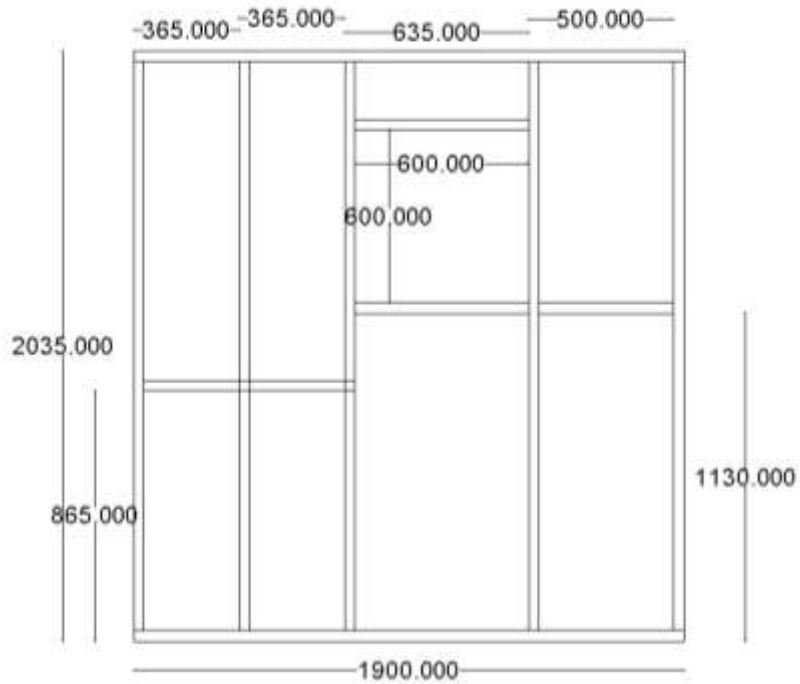
Face Frame Proclima
